HISTORIC STRUCTURE REPORT

STENTON PRIVY
18TH AND WINDRIM STREETS
PHILADELPHIA, PENNSYLVANIA

PREPARED BY JON GRAVES

MARCH 1985

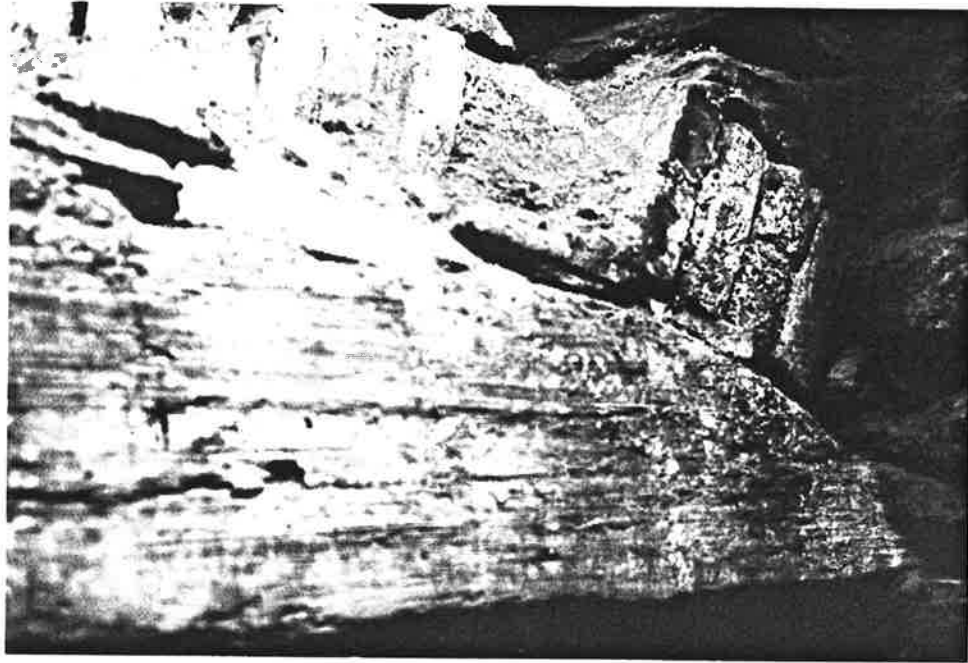
Photograph 1
Bow-shaped Hewn Beam Pocketed into the Pit's Stonework

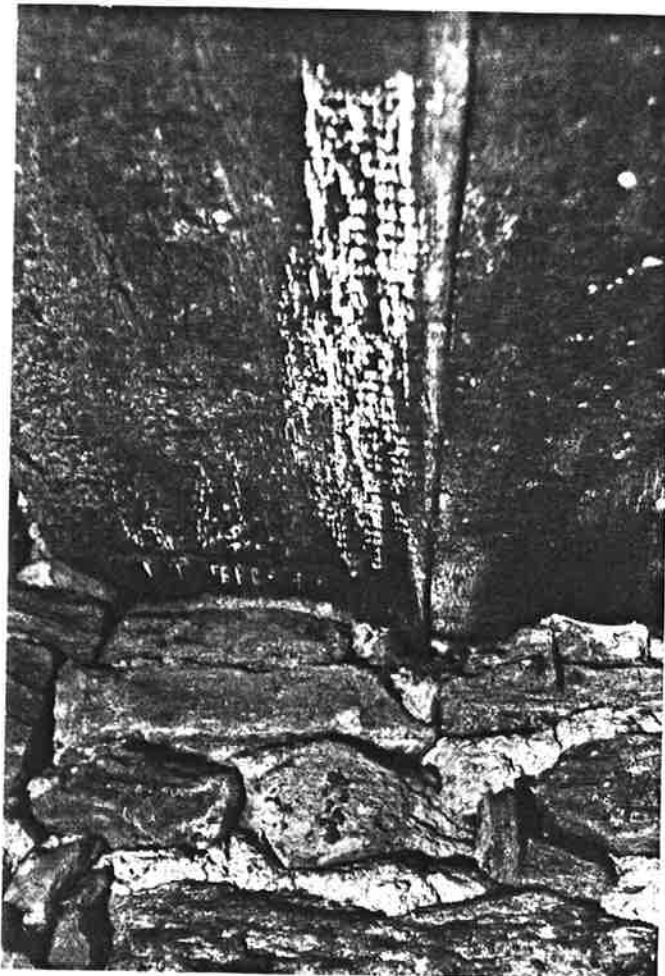
Photograph 2
Cedar Plank Formwork

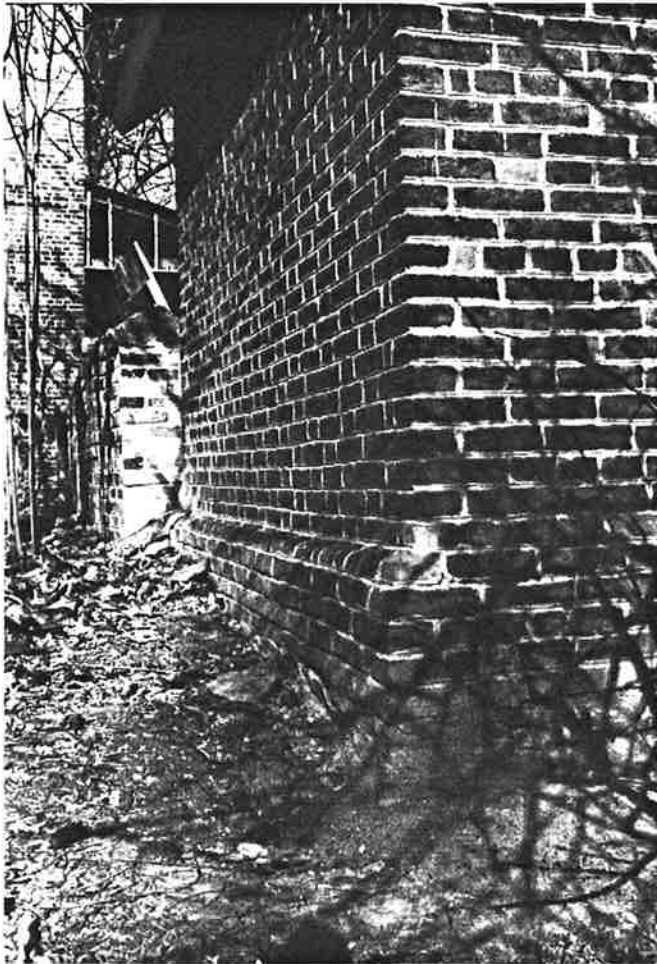
Photograph 3

The southeast and northeast corners of the privy's foundation are visible above grade. The stonework of the north and east and the south and east is integral at the corners where the foundation walls meet (Photograph 3). It appears, above grade, that the foundations and the brick walls were constructed in a single phase. After reviewing archaeological records of the privy and doing some investigation of the subsurface conditions of our own, the foundation system discovered was more complicated than suggested above.

Foundation Stonework at the
Southeast Corner

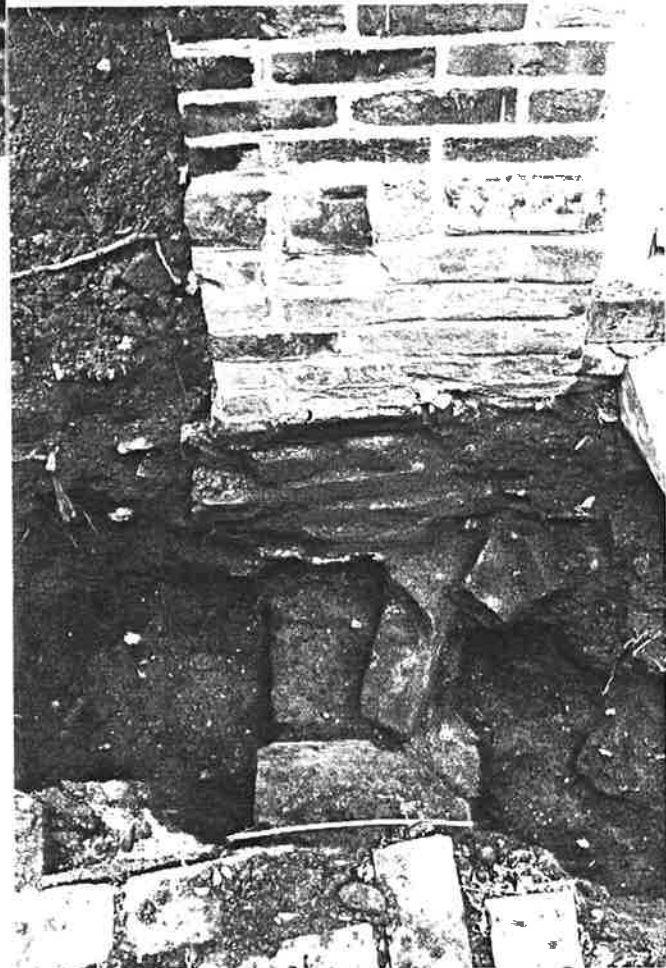
Photograph 4

In the archaeological investigation the east foundation was discovered to be part of a continuous foundation wall system extending into the foreyard of the main house. In our study of the subsurface foundation conditions at the northwest corner, a stone wall was discovered approximately 16" below grade, serving as part of the privy's north wall foundation and continuing west toward the main house (Photograph 4). The two lower foundation walls apparently are part of the same earlier wall; whether this was a garden or building foundation wall is difficult to say but because of the depth of the foundations below grade, we do know the grade level was approximately 16 inches lower. The brick water table on the privy's west and south walls stops at existing grade which indicates the brick walls were built after the ground level had been increased over the earlier stone walls. The lower wall must therefore have originally served as an old building wall or garden wall foundation and later, some

Subsurface Foundation
Wall Discovered at
Northwest Corner

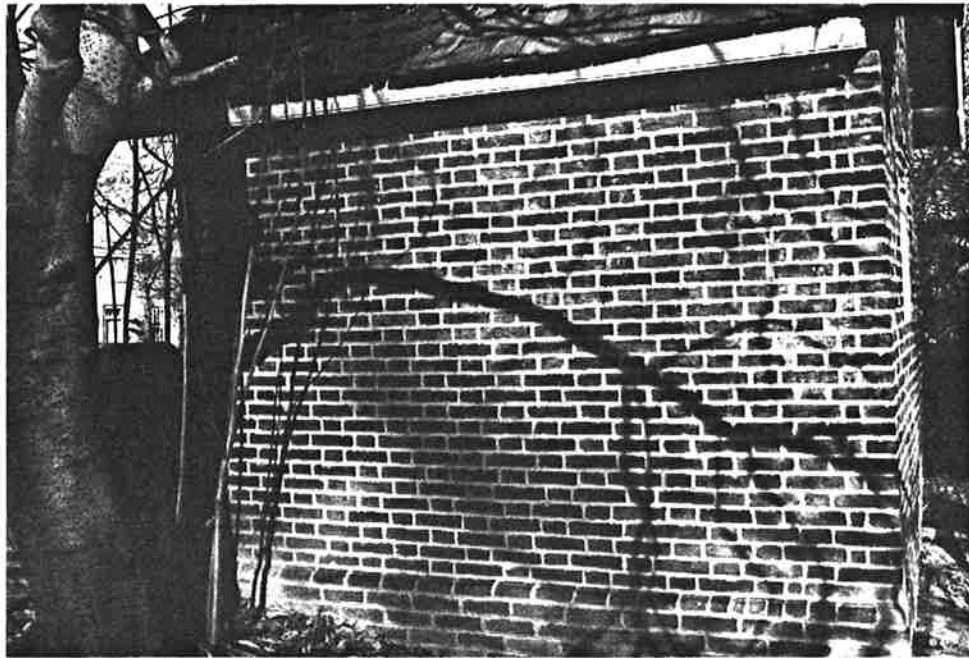
Photograph 5

The south elevation is the only wall that shows a true consistency in the bond without breaks in the pattern (Photograph 5). This elevation is therefore least suspect of alteration since its original erection.

South Elevation

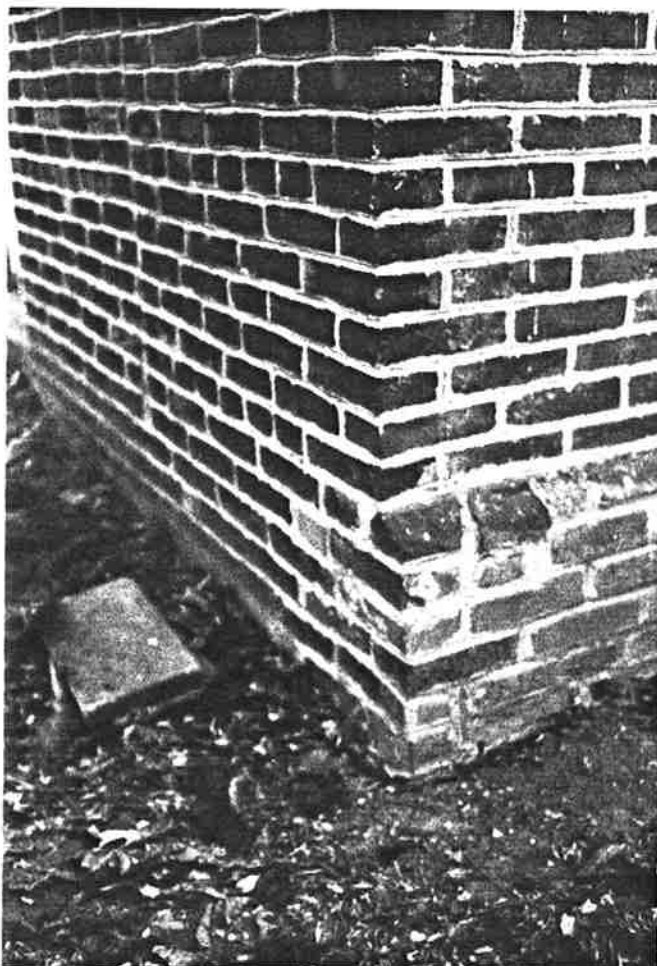
Photograph 6

Northwest Corner showing water table base where the brick configuration suggests originally the last three inches were left unfinished and later patched to match.

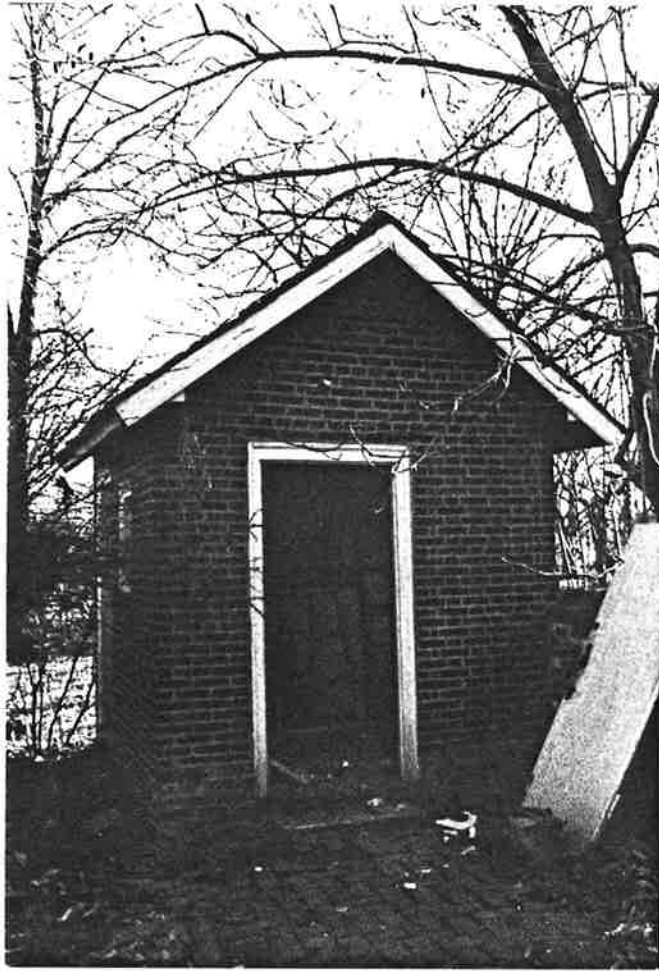
Photograph 7
West Elevation

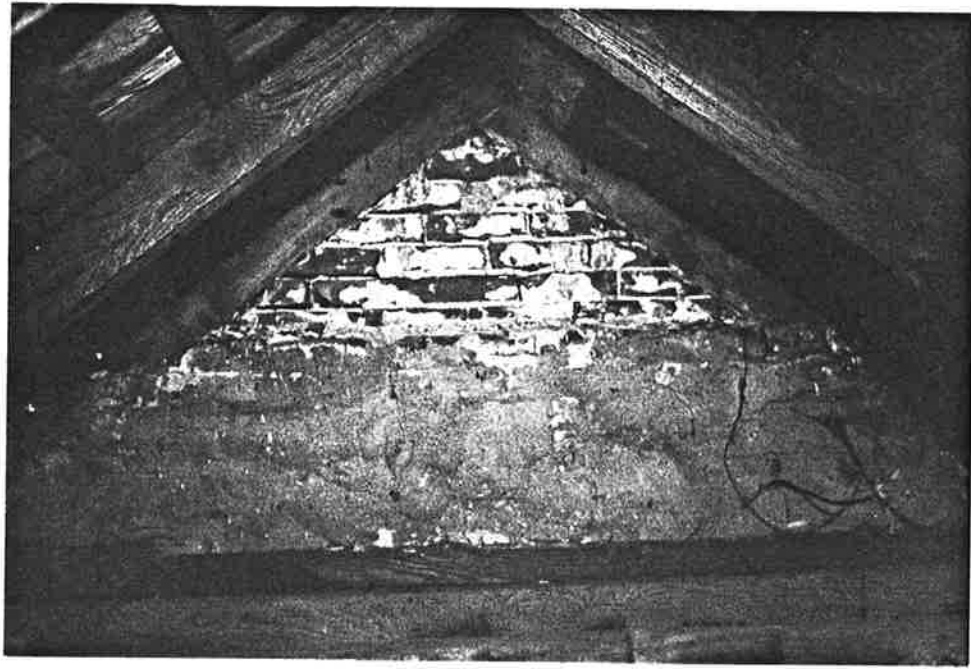
Photograph 8
West Gable Viewed from the Attic Space

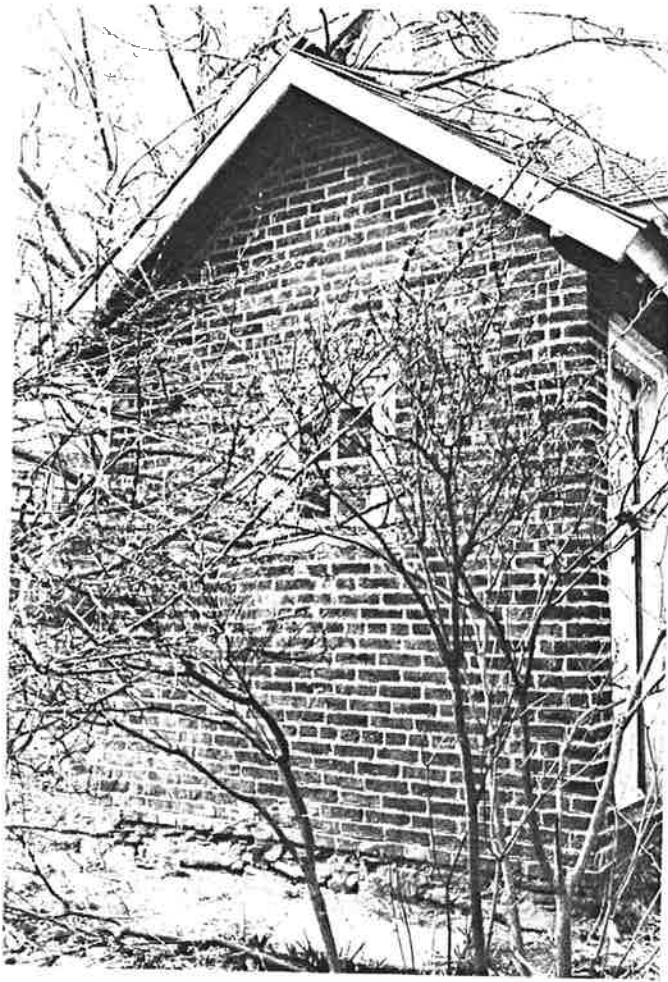
Photograph 9
East Elevation

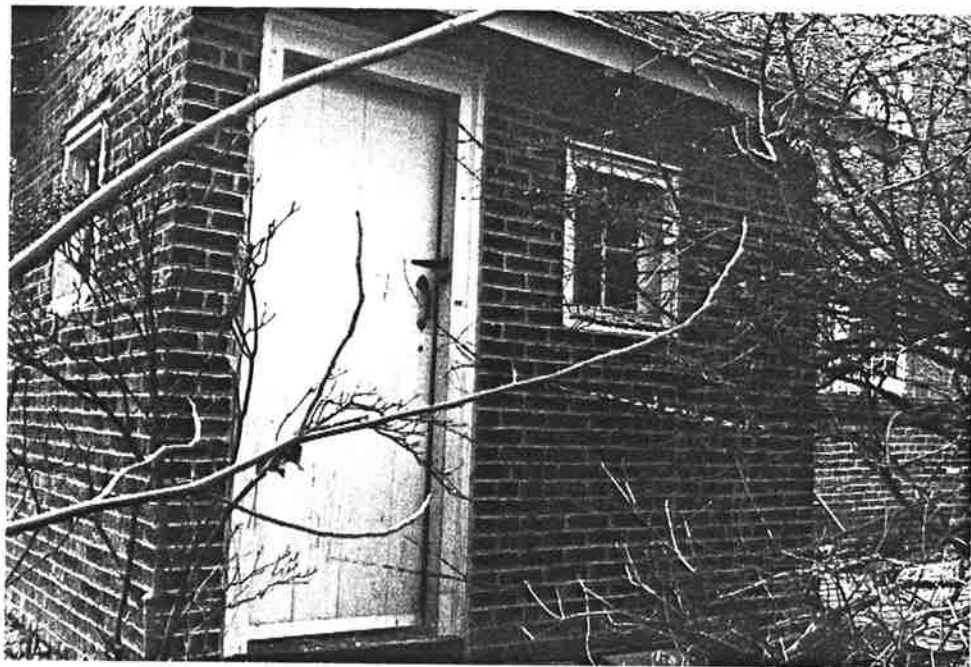
Photograph 10

The north wall contains the most extensive evidence of alterations (Photograph 10). Below the right jamb of the window a

North Elevation

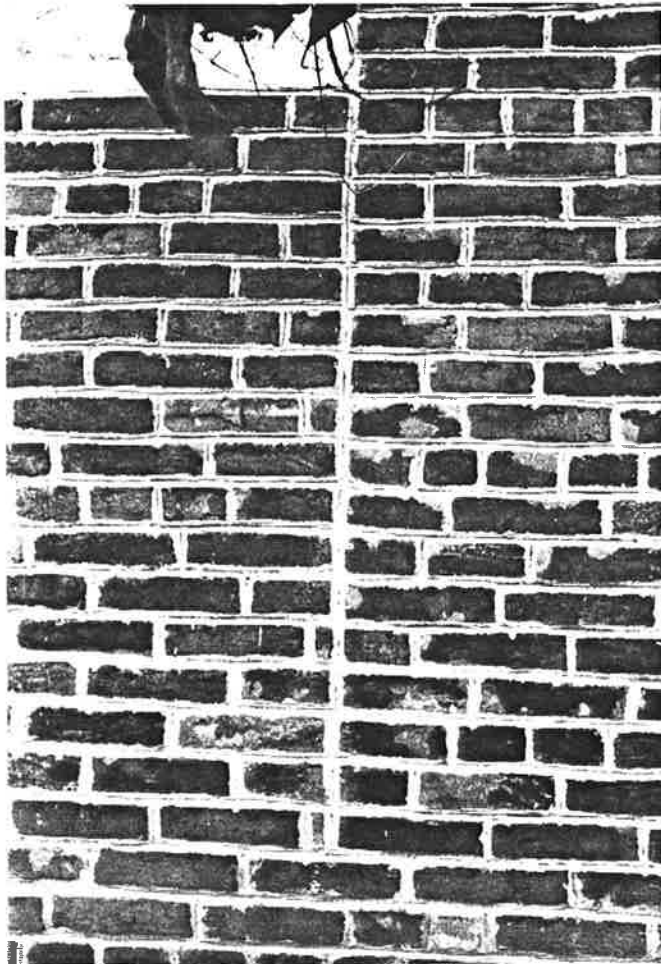
seam is visible between sections of the brickwork (Photograph 11). This seam continues to interior floor level. On the left jamb of the existing door the bricks have been cut in place to allow for the existing doorway (Photograph 12). The original opening must have been in the center of this elevation with the right jamb at the seam. When the door was moved to the west, the brickwork was cut out, and the old door subsequently filled in.

Photograph 11 North Elevation
Seam Below Right Jamb of Window

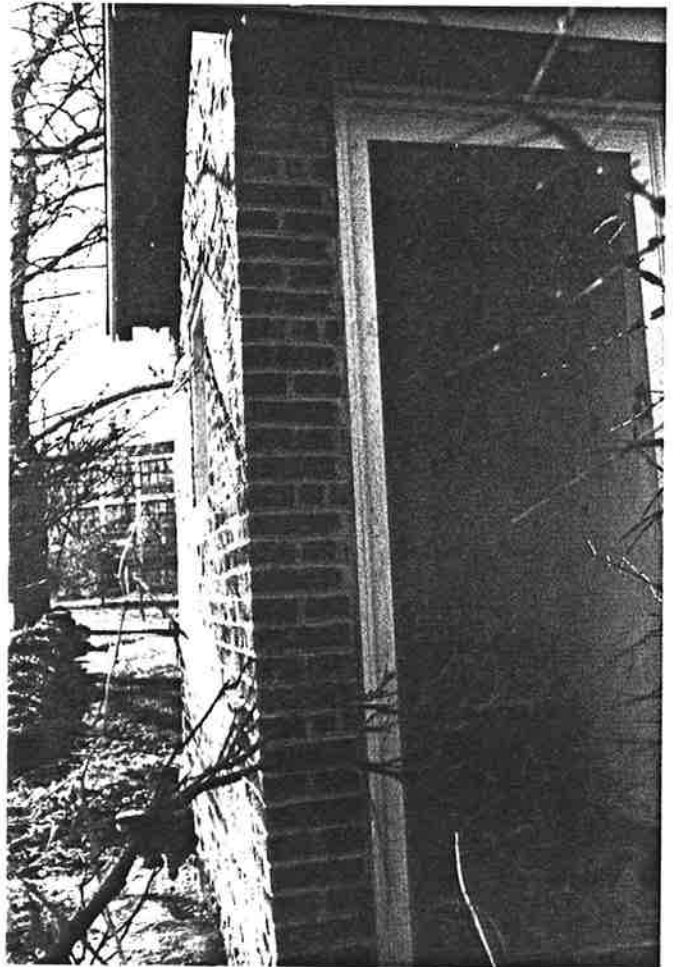
Photograph 12 North Elevation
Cut Bricks Adjacent to Left
Door Jamb

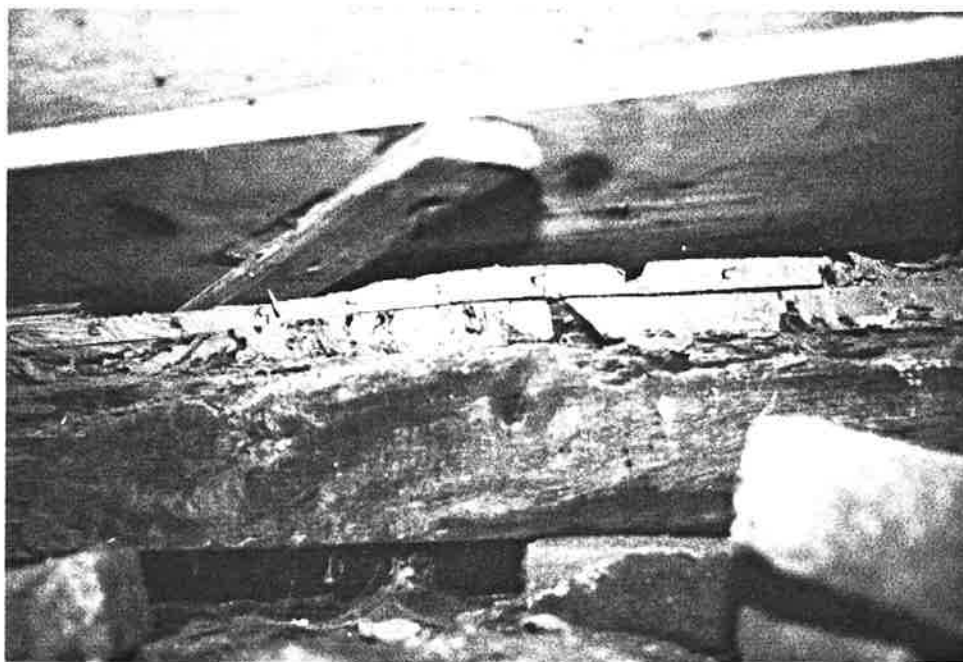
Photograph 14

View of Tongue and
Groove Flooring

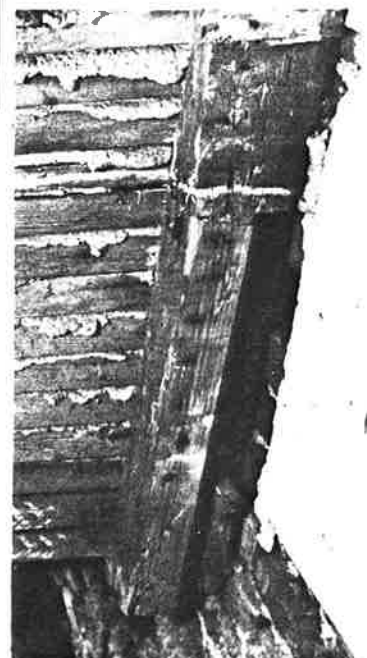
Photograph 15

The Plaster on the South Brick Wall
Ends where the Wood Partition Wall
Intersects

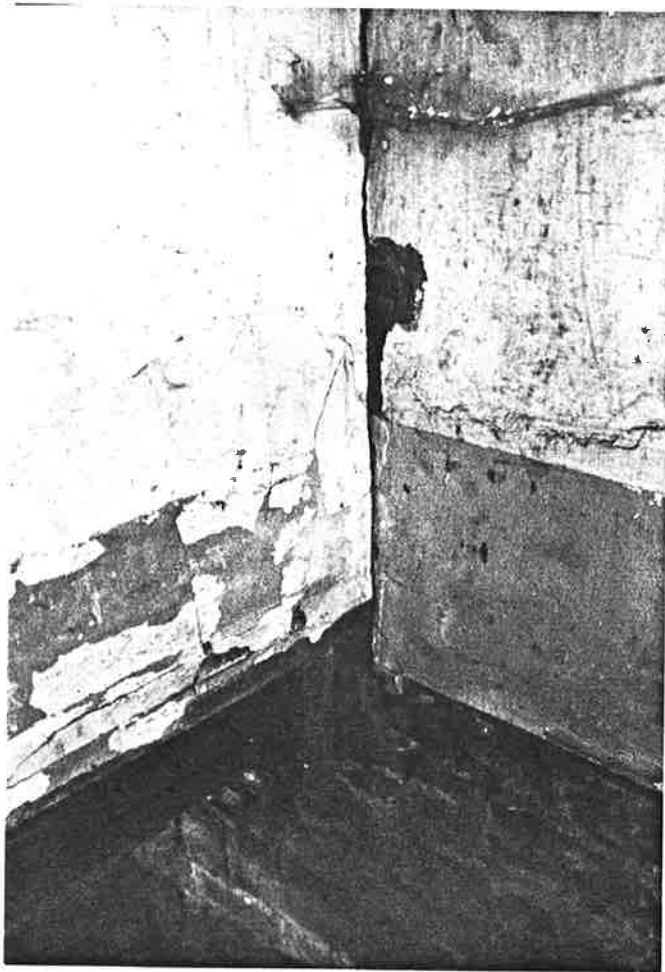
Photograph 16

lower south wall surface (Drawing 10). These areas have been plastered later, but the plasterwork indicates that it was done during a different phase (Photograph 16). Behind the patched space a circular sawn stud was used as a nailer for the later lath (Photograph 17). The ceiling and brick walls must have been plastered at the same time as the introduction and finishing of the partition wall. The lath used is both circular small sweep and sash sawn (the former is typical of the 1830s and 1840s). Lath nail samples taken are of the cut nail type used in the first half of the nineteenth century. Baseboards were also installed during this stage since they are set into the plaster. Baseboard nails are representative of those used around 1840. The baseboards originally were introduced along all the edges of the floor except where the bench was built above the pit opening. There are matching baseboards existing over this section presently but they were added later since they butt the original at the floor's edge.

The Plasterwork Indicates
Two Phases of Application

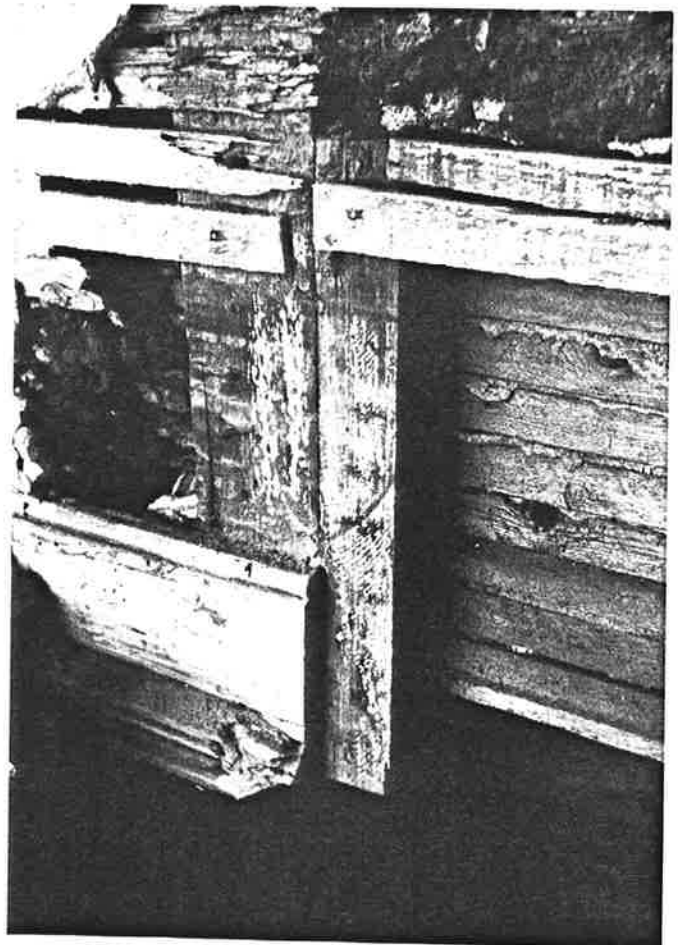
Photograph 17

Circular Large Sweep-sawn
Nailer for Lath Used to
Patch the Hole

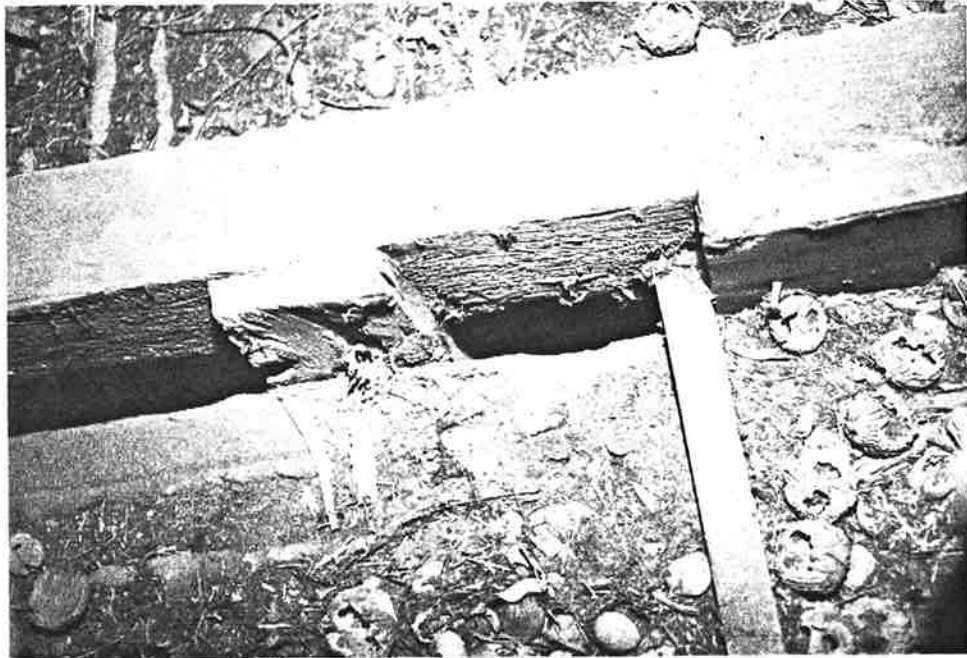
Photograph 18

Partition Wall Stud Connection to Ceiling Joist Above

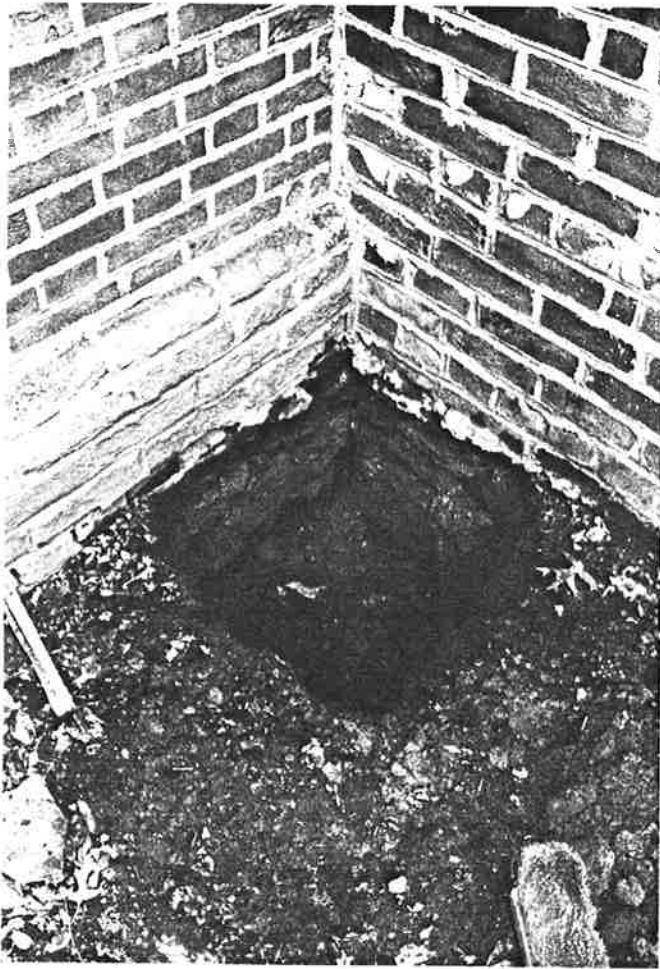
Photograph 19

Southwest Corner Connection to
Existing Garden Wall Showing
Butt Joint
