HISTORIC STRUCTURE REPORT

STENTON PRIVY
18TH AND WINDRIM STREETS
PHILADELPHIA, PENNSYLVANIA

PREPARED BY JON GRAVES

MARCH 1985

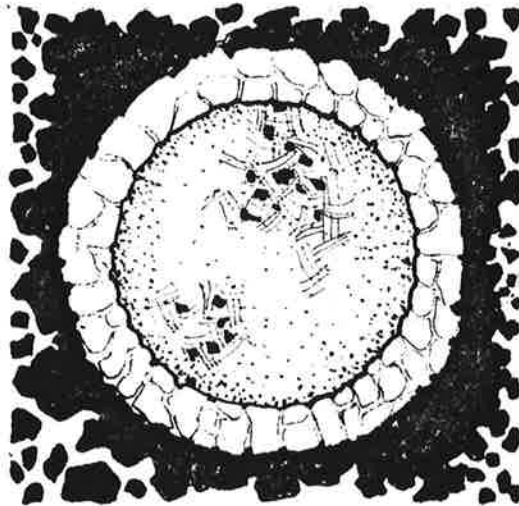
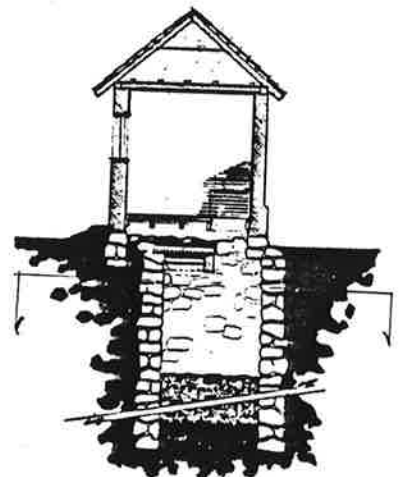
Drawing 1

Although appearing to be uniform in plan at elevations minus 4 feet and below, a brick vault in the upper 4 feet of the pit spans the opening capping off approximately half of it. Drawing 2 shows a cutaway view of the vault over the pit. A hewn bow-shaped beam and cedar planks were integrated with the original stone wall construction at the top of the cylinder to provide formwork for the brick vault to be laid above (see Photographs 1 and 2). The chalk rubbing on the underneath side of one of the cedar planks displays the utilization of a sash-sawn milling process.

This plan shows the privy pit's construction at levels more than four feet below grade.

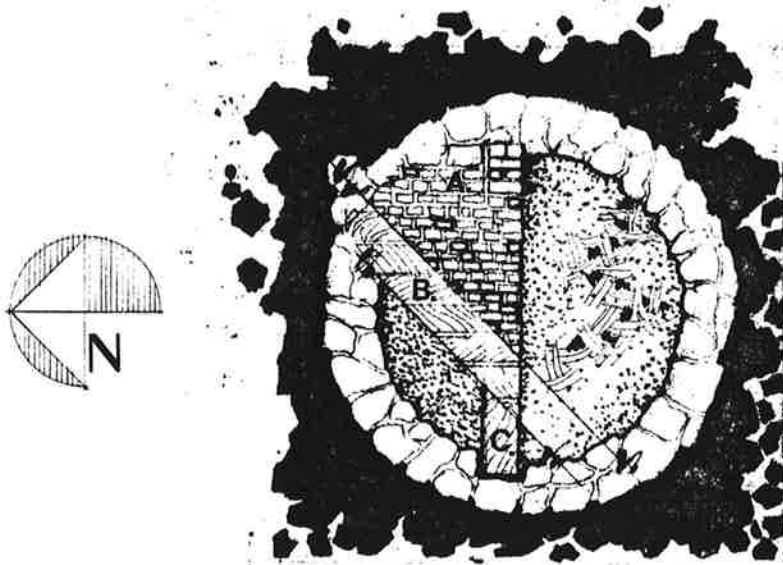
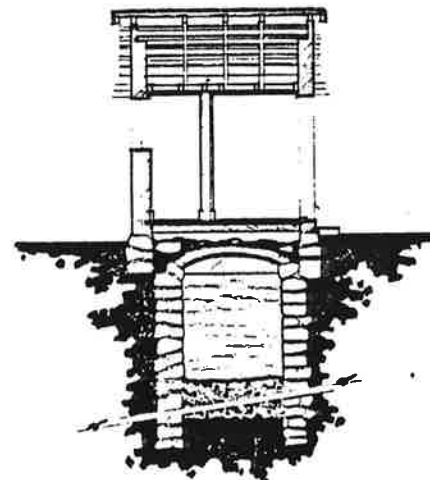
Drawing 2

This cutaway plan shows the vault construction 3 feet below grade. The vault closes approximately one-half of the pit opening.

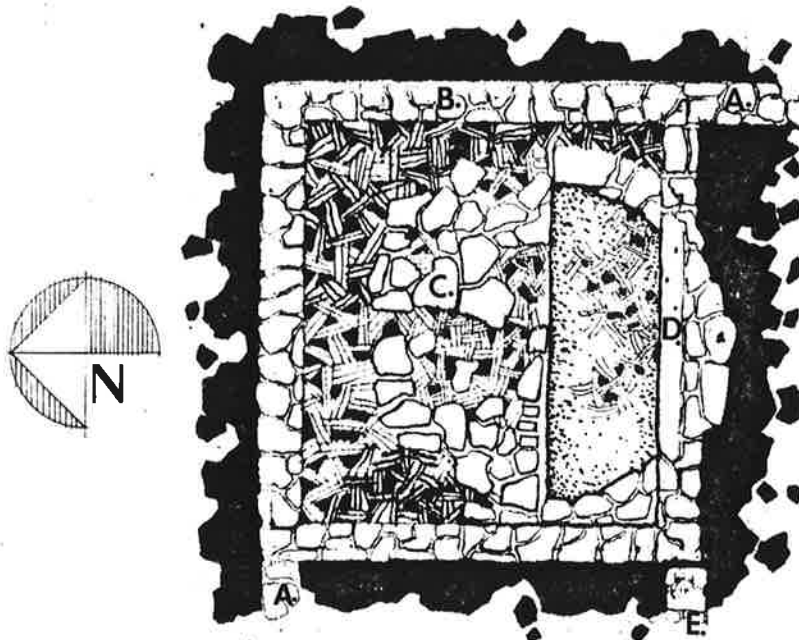
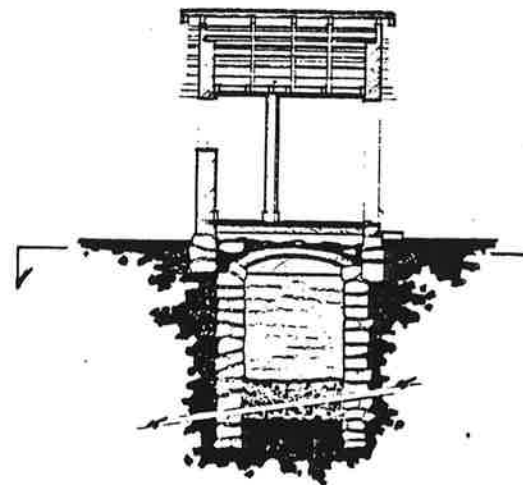
Drawing 3

The southeast and northeast corners of the privy's foundation are visible above grade. The stonework of the north and east and the south and east is integral at the corners where the foundation walls meet (Photograph 3). It appears, above grade, that the foundations and the brick walls were constructed in a single phase. After reviewing archaeological records of the privy and doing some investigation of the subsurface conditions of our own, the foundation system discovered was more complicated than suggested above.

This plan depicts the stone foundation of the privy in relationship to the pit and associated foundation walls.

From the inside of the pit the overlap of the privy's foundation and the pit was determined. The pit is not centered underneath the building shell from north to south so the bench above may be against the south wall and centered over the pit. A schist lintel supports the south wall where the wall overhangs the pit. The pit is not centered under the shelter from east to

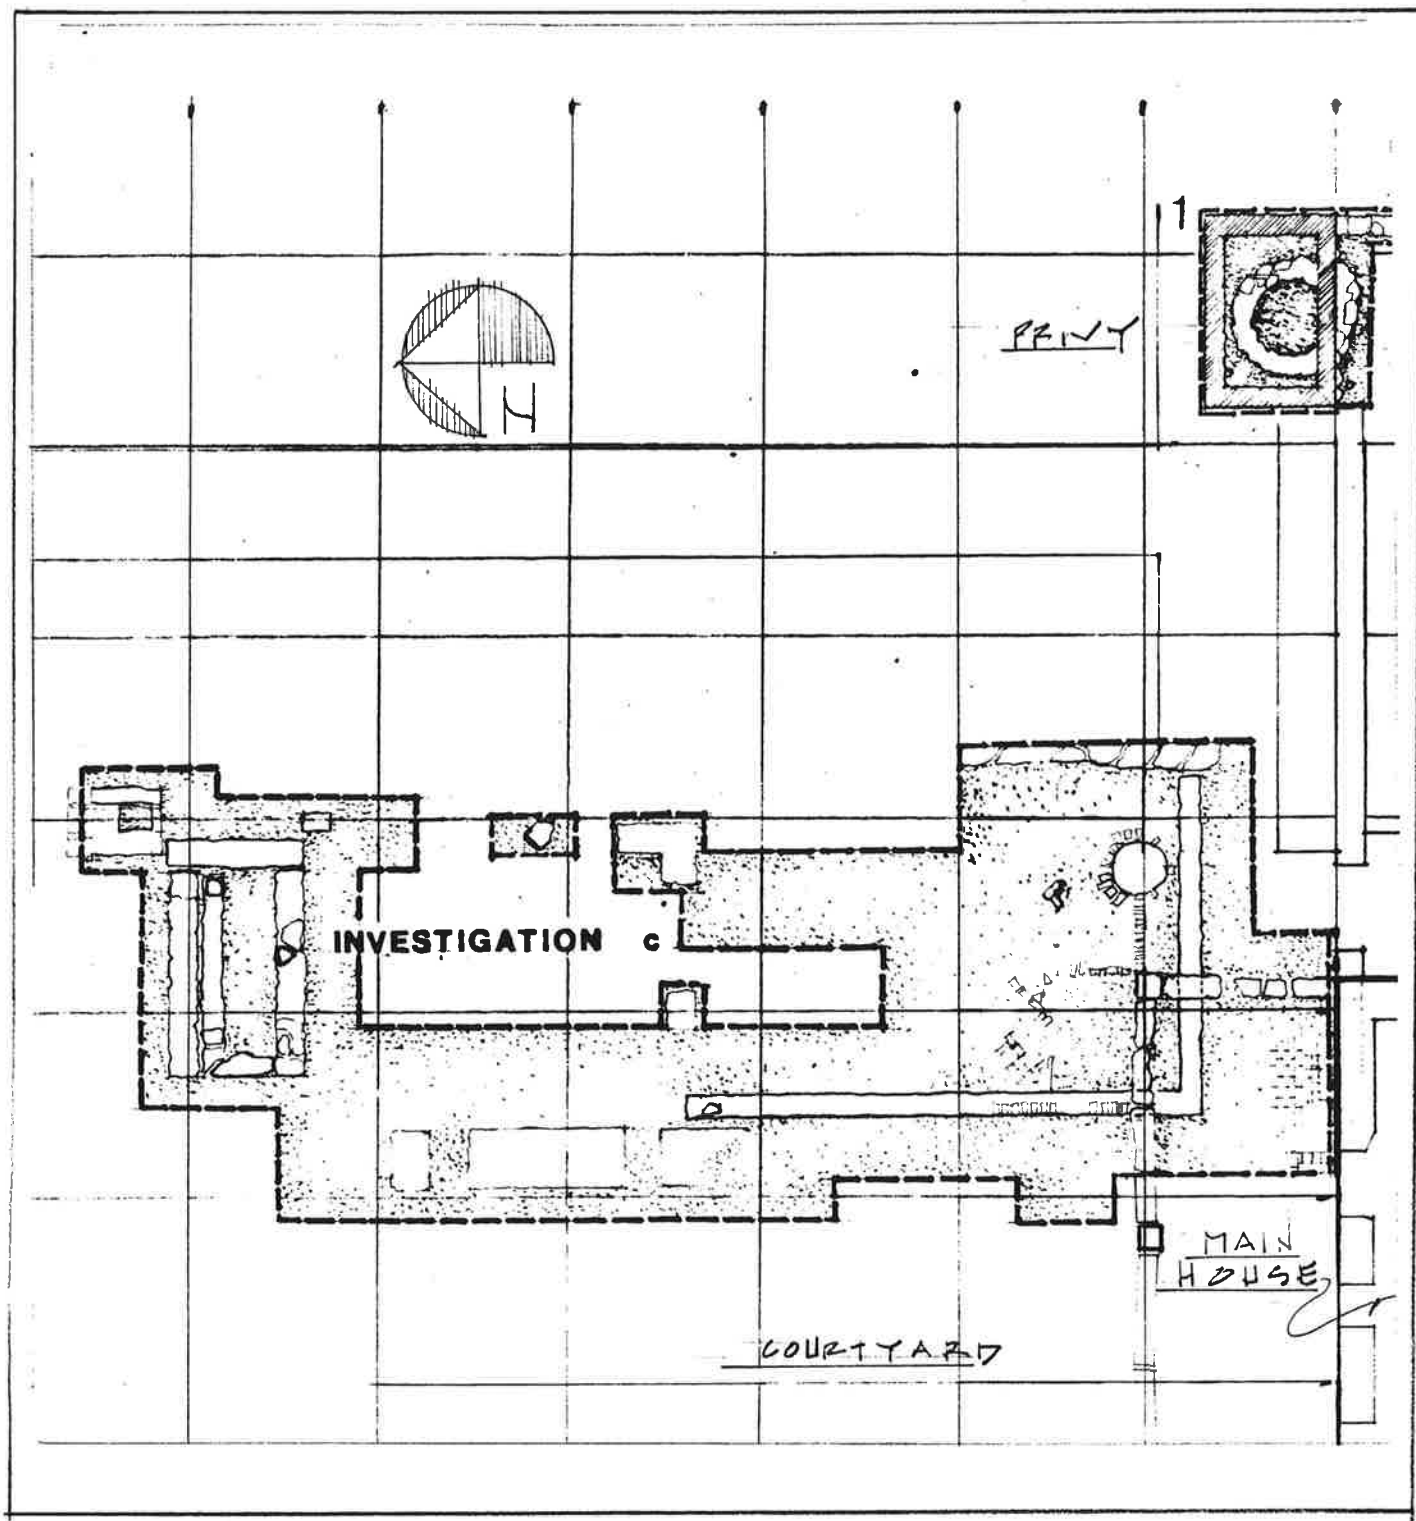
Drawing 4

time after the wall above was removed been used as the base for the privy's north and east foundation walls. Archaeological research completed in 1983 by Dr. Liggett indicated previous buildings or garden walls were located on the east boundary of the courtyard (Drawing 4). Reed Engle, in the Stenton Mansion Historic Structure Report, recorded the corresponding foundation relationships at the southeast corner of the piazza in section and plan (Drawings 5 and 6). When the privy foundation walls are compared the early stone wall under the privy closely matches the earliest under the piazza foundation in elevation and alignment. The privy's upper foundation walls correspond in elevation with the intermediate piazza paving area. One might think the grade around the privy would have been increased dramatically above the piazza grade level when the pit was dug, invalidating the comparison between the latter. Although this is a possibility, the resulting slope of the land would have not only been awkward in appearance but drained the yard toward the house. The placement of the excess dirt was more likely strategically distributed to create both an even grade in what was probably the northeast corner of a garden and along the circulation to and from the house. This would then explain some of the rise in the surface of the piazza.

Taken from Stenton Mansion Archaeological
Summary Drawing. Information based on field
notes. Courtesy of Dr. Barbara Liggett.

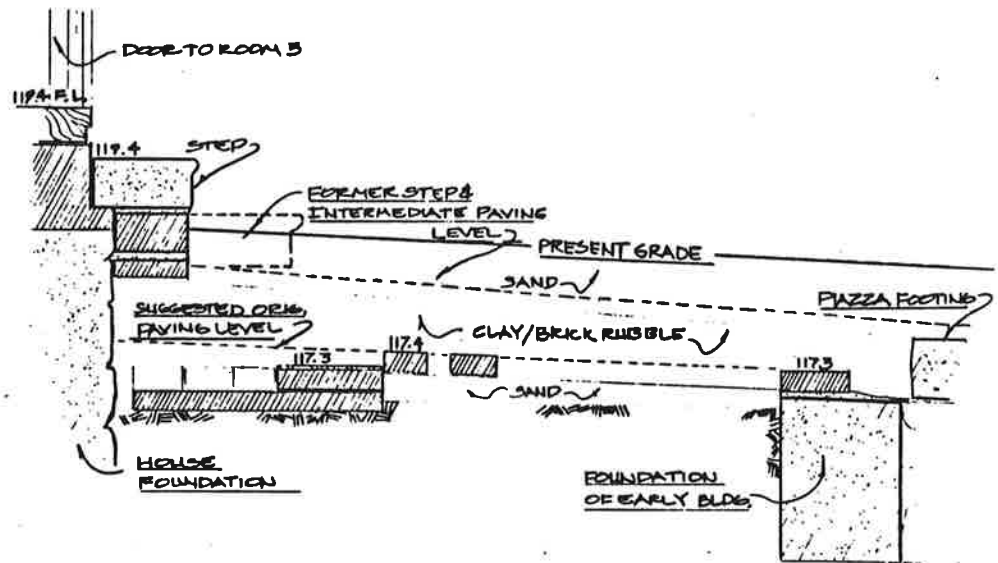
Drawing 5

This section points out the foundation of the early building which appears in grade elevation and alignment to be the same as the foundation base found under the privy's north wall.

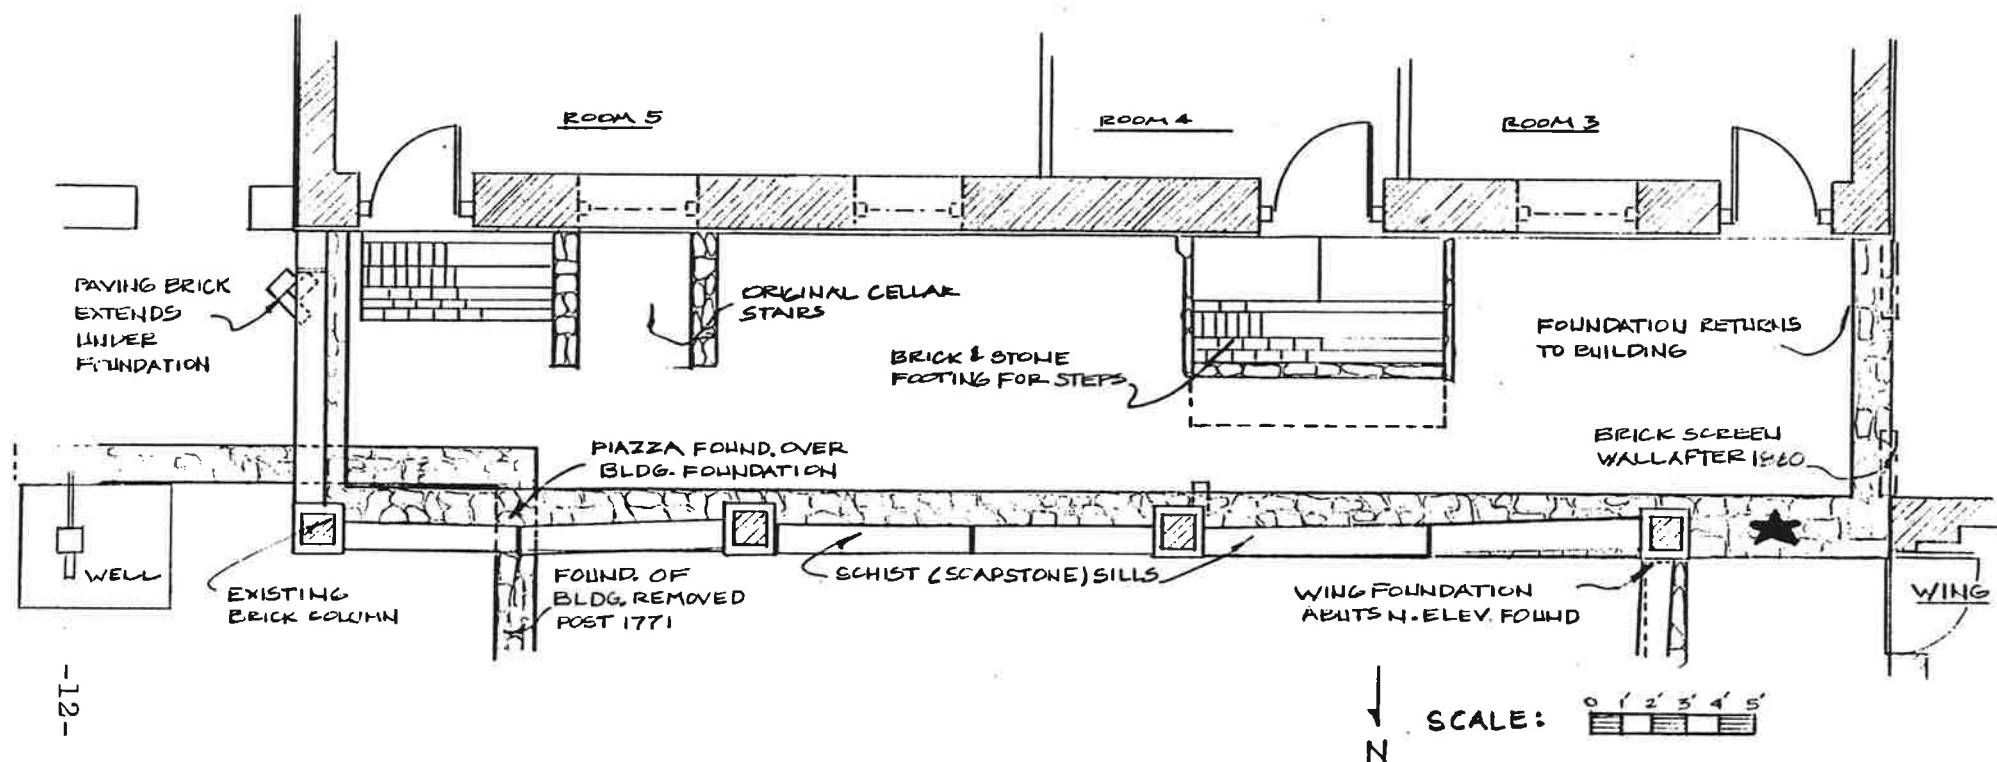
Drawing 6

The foundations of the piazza and the original building beyond the north-west corner of the house indicate that the foundation was built after 1771, and probably after 1794. It is doubtful that the section of the foundation marked with a star could have been built had the wing existed for it would serve no structural purpose. The wing piazza foundation abuts the foundation of the house porch.

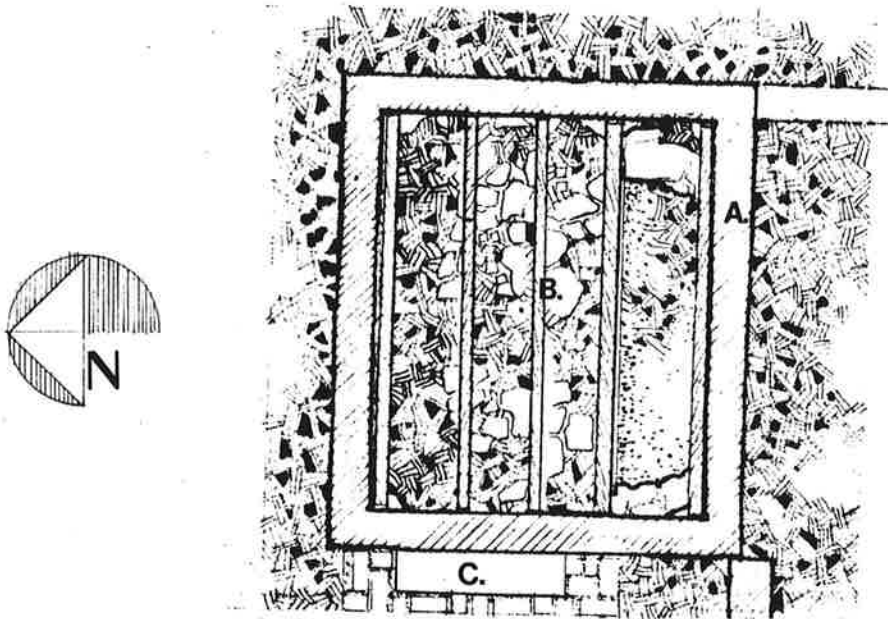
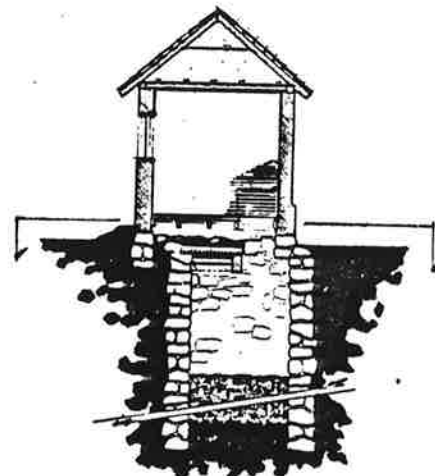
Drawing 7

The existing floor structure is composed of 3" x 5" joists above the pit vault and 3 layers of flooring. The ceiling and roof framing structure is of 3" x 4"s. The partition is a stud wall composed of five 3½" x 3½"s, finished with plaster and lath, like the ceiling. The floor joists span east to west (Drawing 7), and are not pocketed into the brickwork at their ends but rest on the top of the stone foundations. They are sash-sawn (Photograph 13), and are spaced approximately 1'-6" on centers.

This plan shows the start of brick wall construction and floor support system just above ground level. Note floor joists are suspended above the vault of the pit.

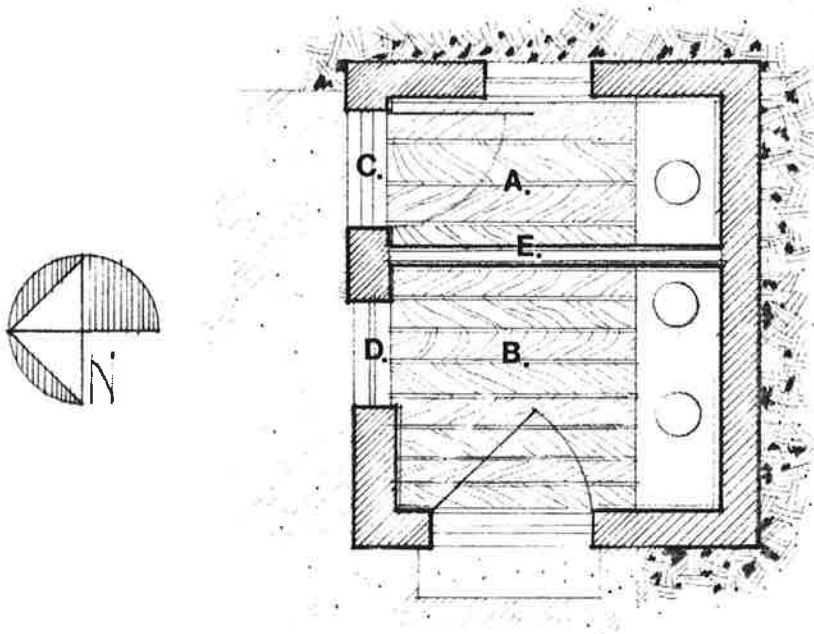
Drawing 16

The frame partition wall, built around the bench and the alterations to the north wall separated the original privy plan into two rooms.

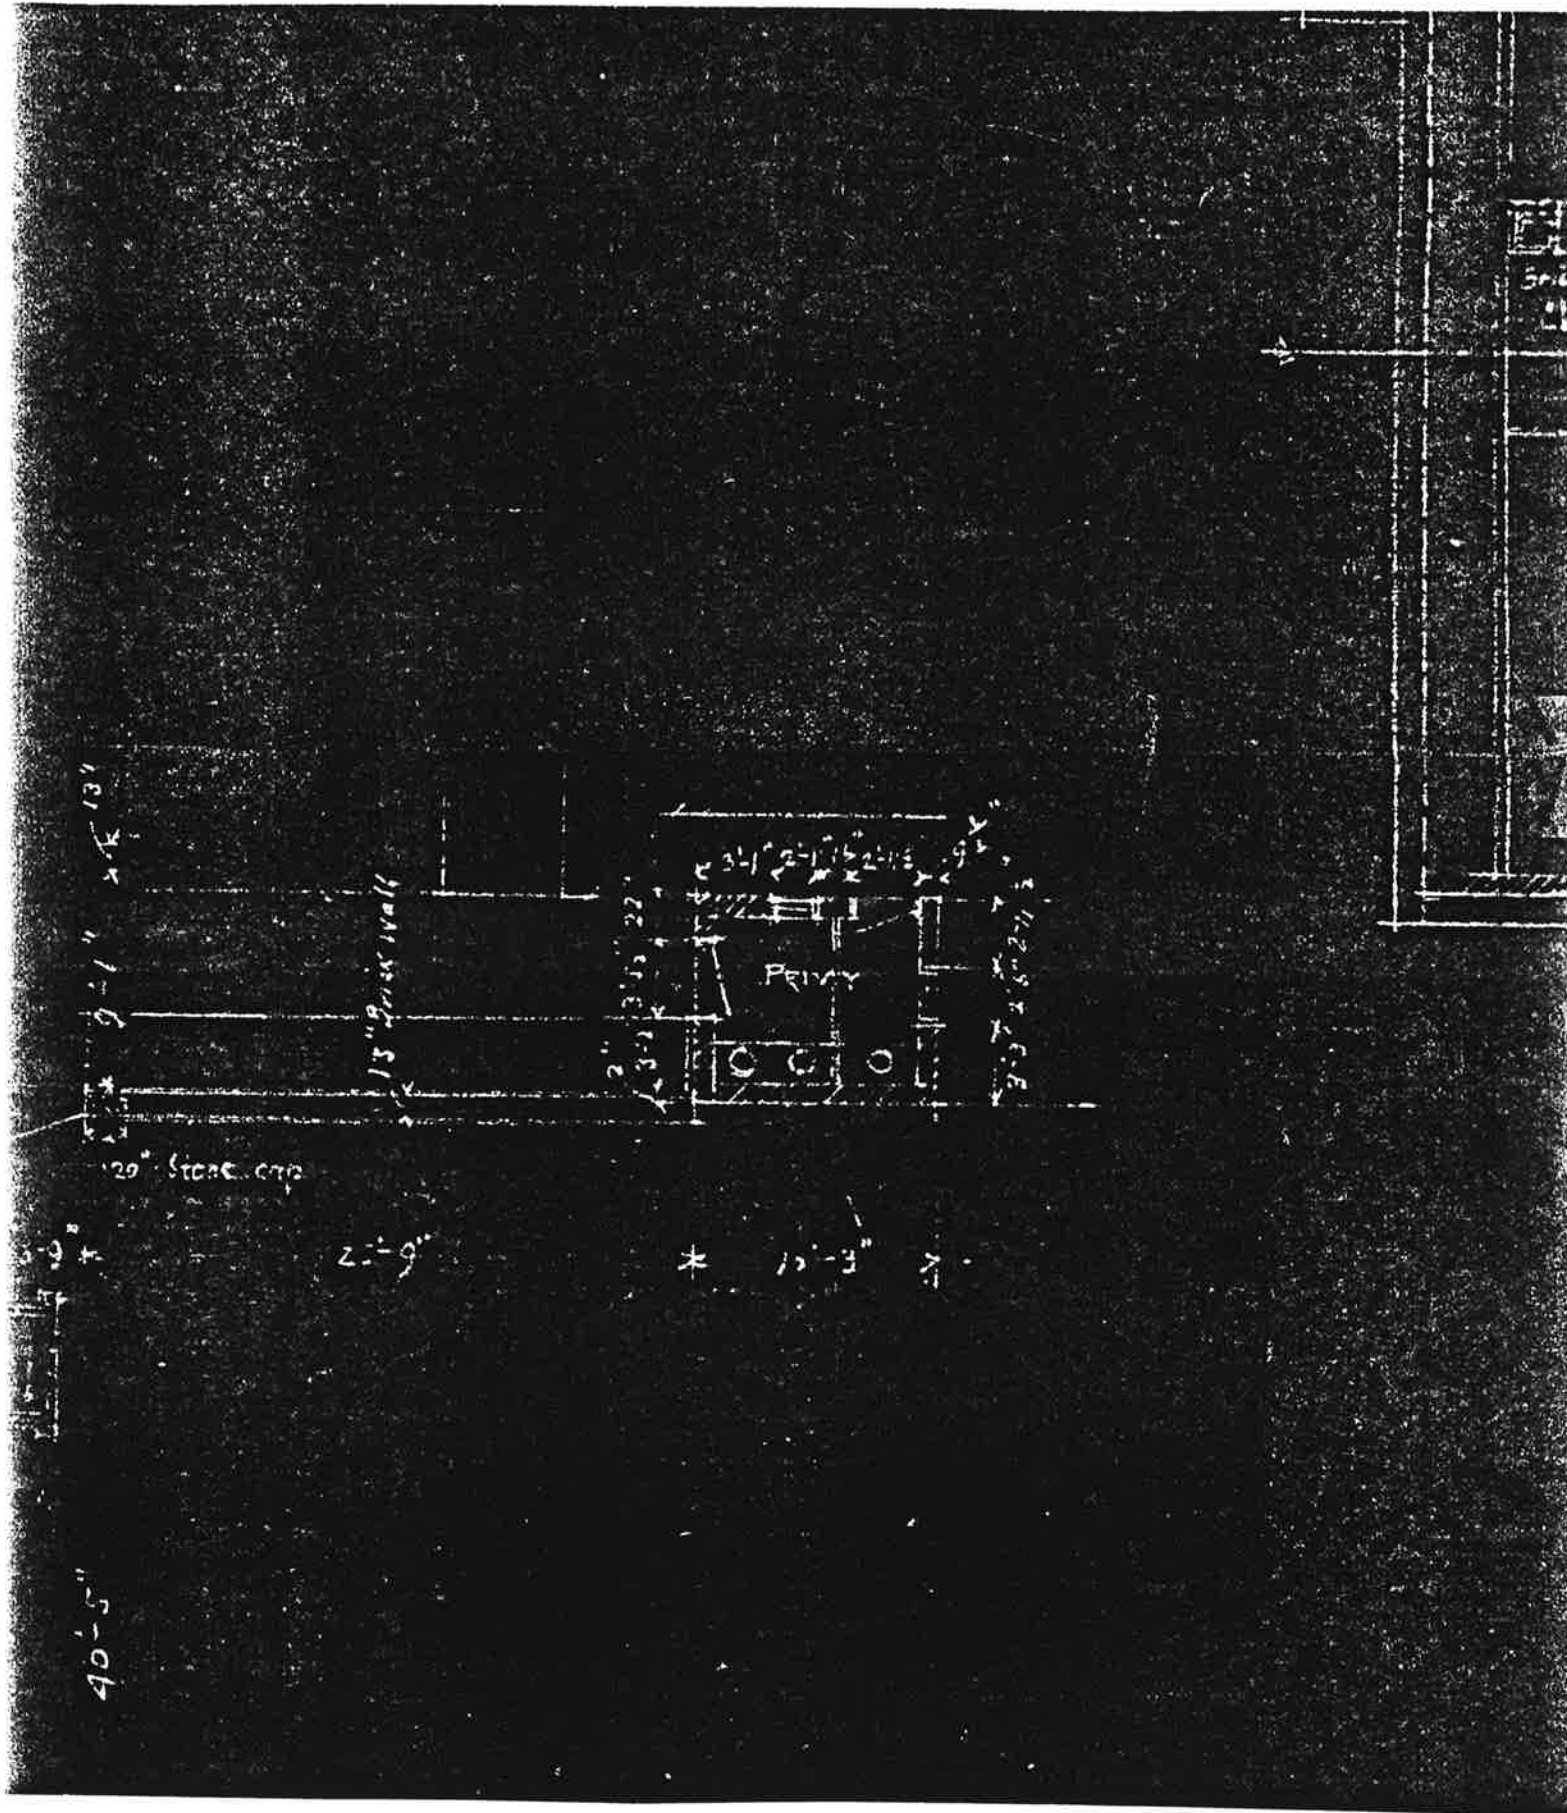
Drawing 17

A 1907 Cope and Stewardson plan of the existing conditions at Stenton confirms our interpretation of the privy's layout in this phase (Drawing 17). In addition to confirming our evaluation, this record also indicates this configuration was retained into the twentieth century.

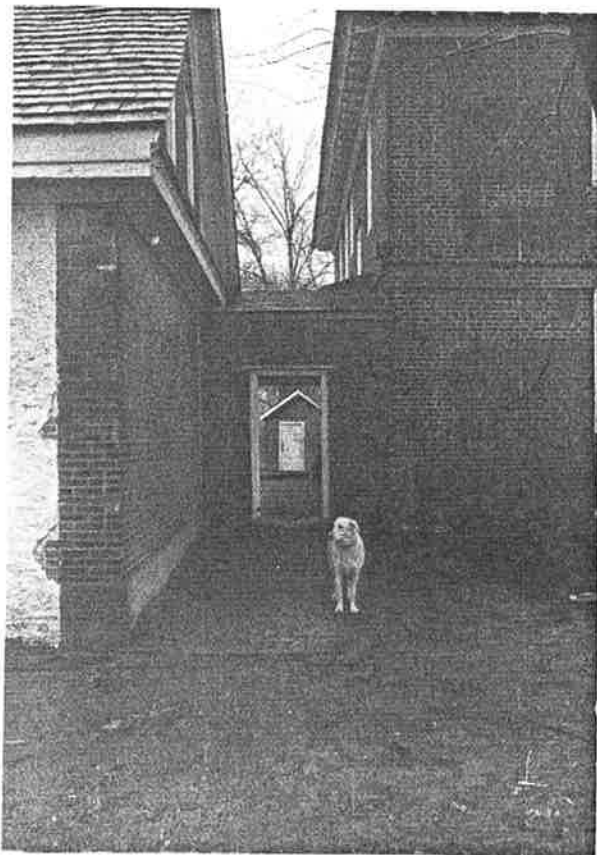
The physical evidence suggests that the existing building was originally designed to serve both the main house and the activities occurring on the property north of the privy. Photograph 20 shows the formal position of the privy and its west door in the context of the main house and kitchen wing.

View of the Privy across
the Piazza from the West
